INSPECTION ORDER FORM

100 Main St. Anytown USA 76543

David W. Alderson, Home Inspector

Summary Letter

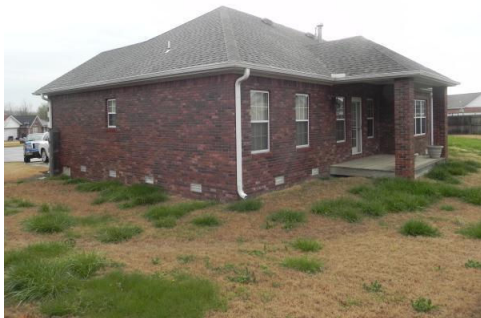
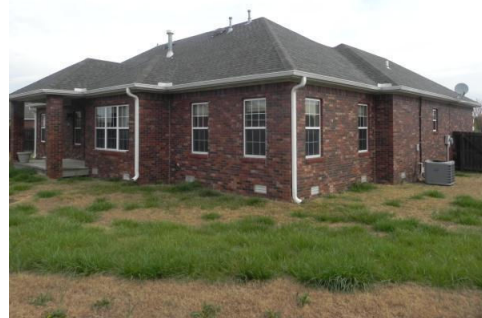
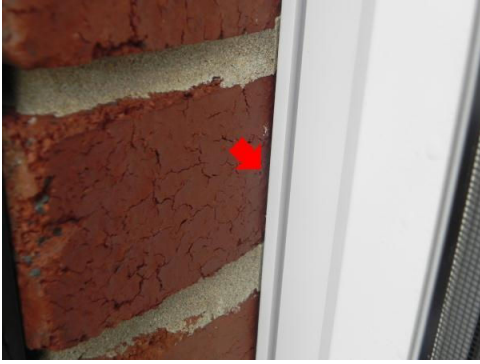
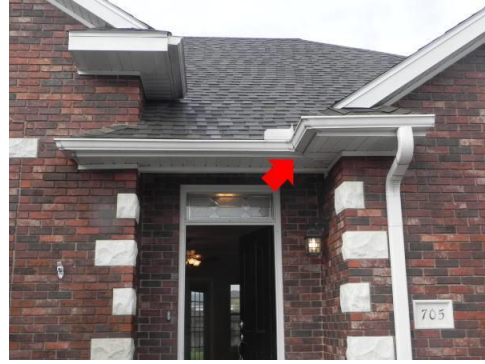
Exterior Walls

Cladding Material:	Brick.
Is Aluminum or Steel Siding Grounded?	No.
Condition of Material:	Appears serviceable.
Additional Comments:	Brick seems to be in good Shape. Only Concerns Would be that the Windows are not Siliconed to the Brick to Prevent Infilltration. Some Gutter not Draining towards the Downspout.

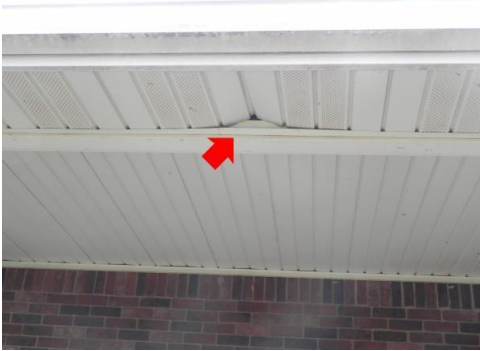
Trim

Cladding Material:	Metal.
Condition of Material:	Appears serviceable.
Additional Comments:	Appears to be in good condition for age. Found area for Infiltration. Near Back Porch Area

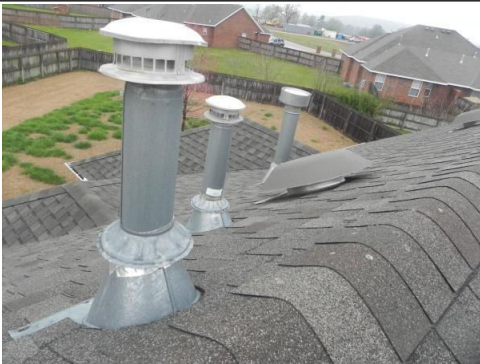
Chimney

Material:	Metal.
Condition of Material:	Appears serviceable.

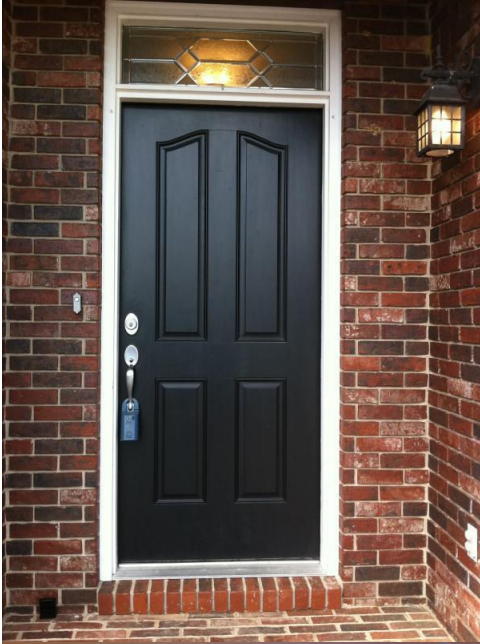
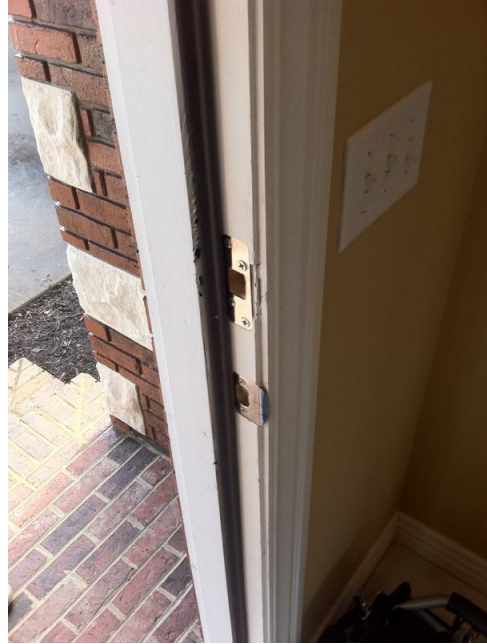
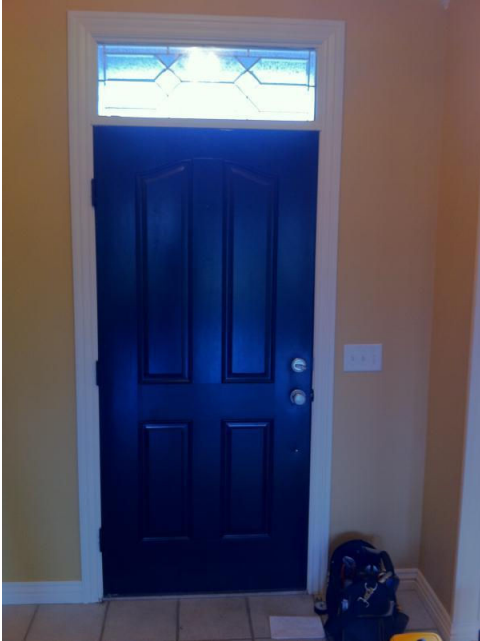
Exterior Door (Main)

Main Entry Door Material:	Metal.
Door Material Condition:	Appears serviceable.
Additional Comments:	Some Cracking in the Weather Stripping

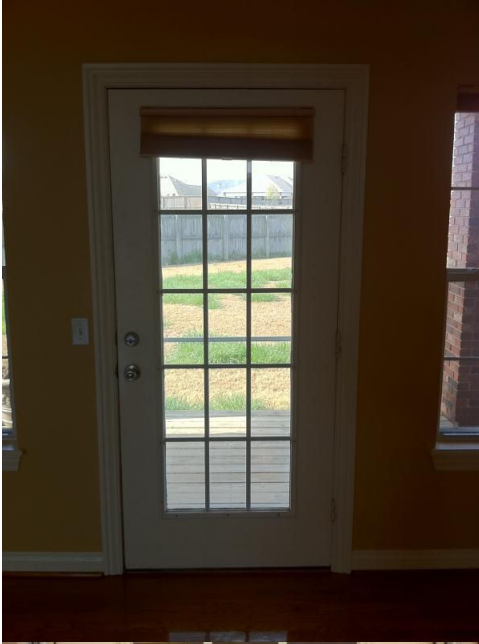
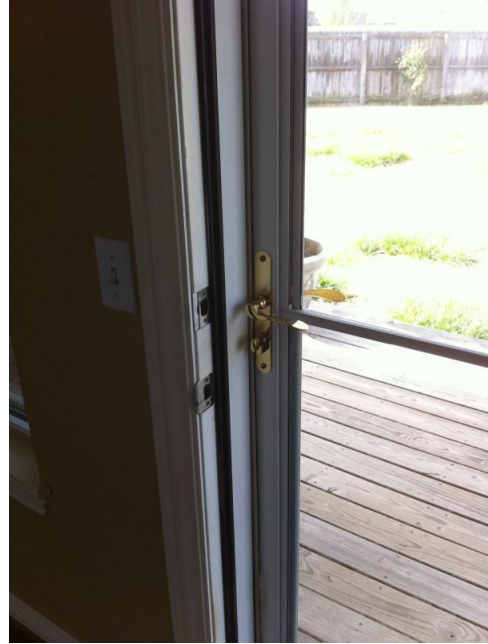
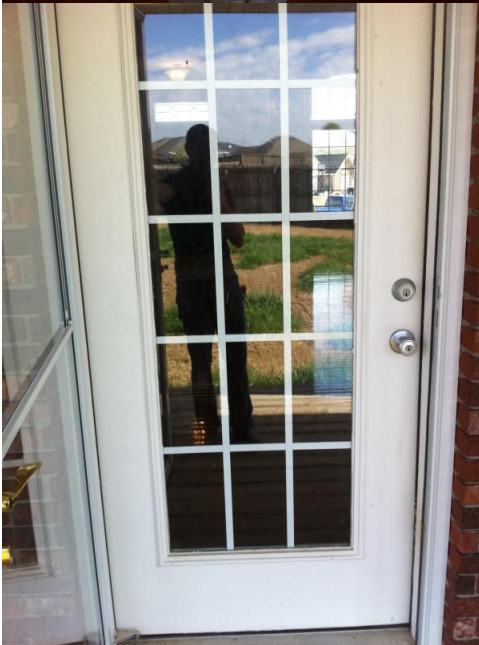
Exterior Door (Other)

Other Entry Door Material:	Metal.
Door Type:	Standard side and rear doors. Storm door installed.
Door Material Condition:	Appears serviceable.

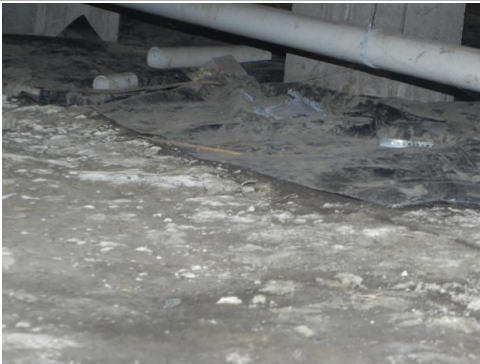
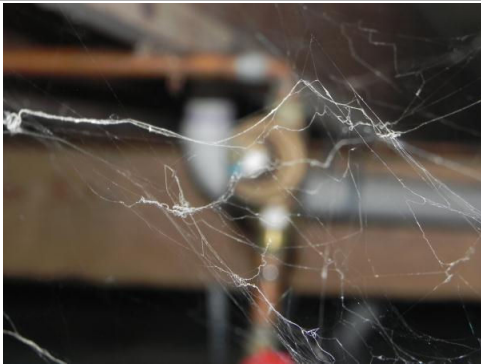
Basement/Crawlspace

How Inspected:	Visually inspected the basement/crawlspace.
Condition:	Crawlspace partially accessible. Partically Damp / No Vapor Barrier Present.
Foundation Material Type:	Concrete blocks.
Foundation Material Condition:	Appears serviceable. Ventilation appears serviceable.

Sub Floor Material:	Plywood.
Sub Floor Material Condition:	Appears serviceable.
Beams Material:	Engineered wood products.
Beams Material Condition:	Appears serviceable. Appears serviceable.
Floor Joist Material:	Engineered wood products.
Floor Joist Condition:	Appears serviceable.
Additional Comments:	Shut off and Pressure Regulator is in the Crawl Space

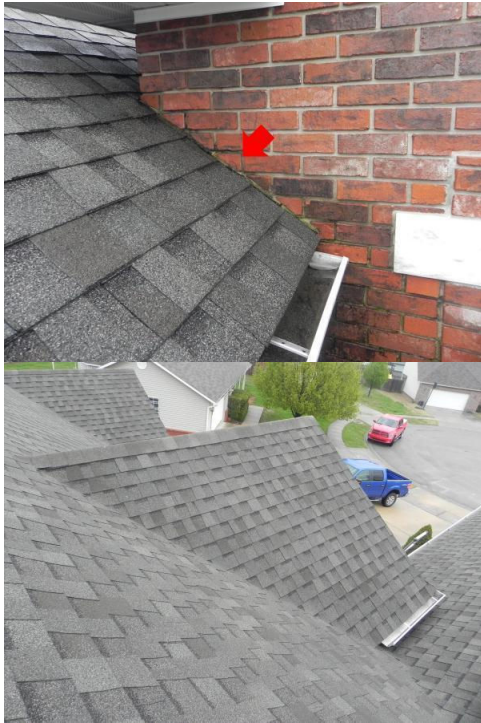
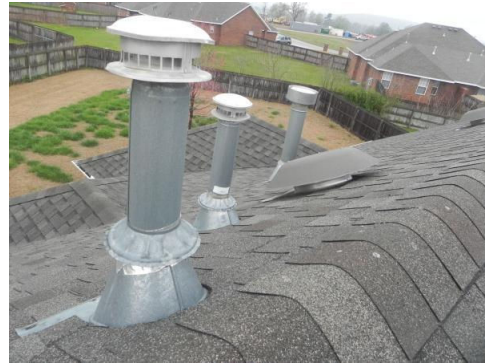
Inspection Method:	Physically walked on some of the roof. Viewed from the ladder. Inspected from ground with binoculars.
Roof Limitations:	Roof too steep. Roof too wet.
Additional Comments:	Could not Find Flashings where Roof and Brick Meets.
Roof Style:	Hip.
Roof Covering:	Asphalt Shingles (Architectural).
Roof Covering Condition:	Appears serviceable/within useful life.

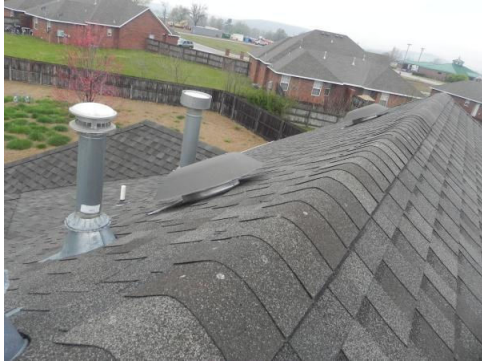
Flashing Material:	Metal.
Flashing Material Condition:	Appears Serviceable.
Additional Comments:	Pipe Flashings and Powervents appear to be in good conditions

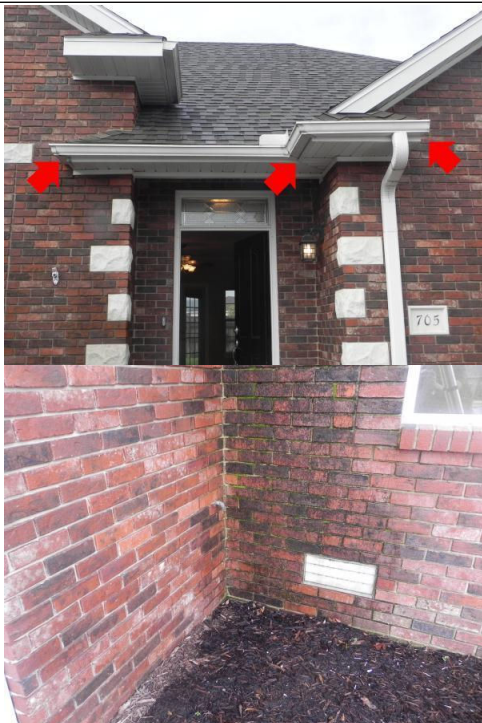
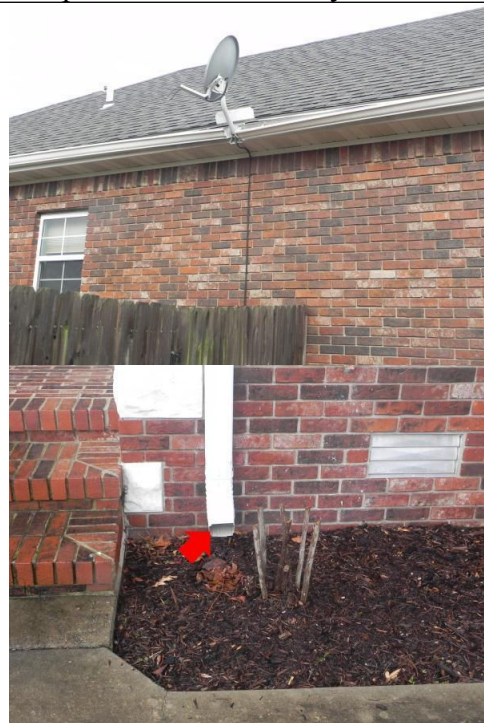
Gutters/Downspouts

Gutter Material:	Metal.
Gutters Condition:	Gutters around entire house. Improper slope noted in various places. Extend downspout away from building. Missing downspouts. Bent gutters.
Additional Comments:	Brick wall next to Garage and front steps show evidence of water from Gutters sloping the wrong Directions. Recommend the Repair and or the Replacment of Gutter System.

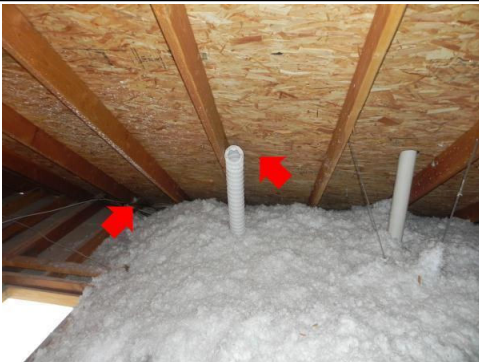
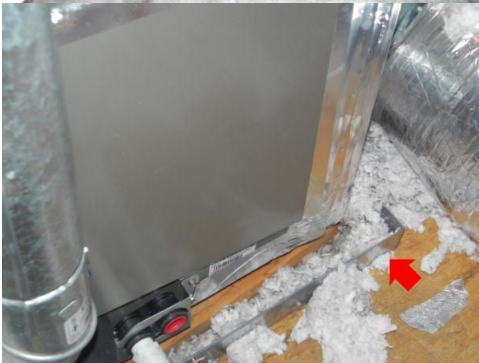
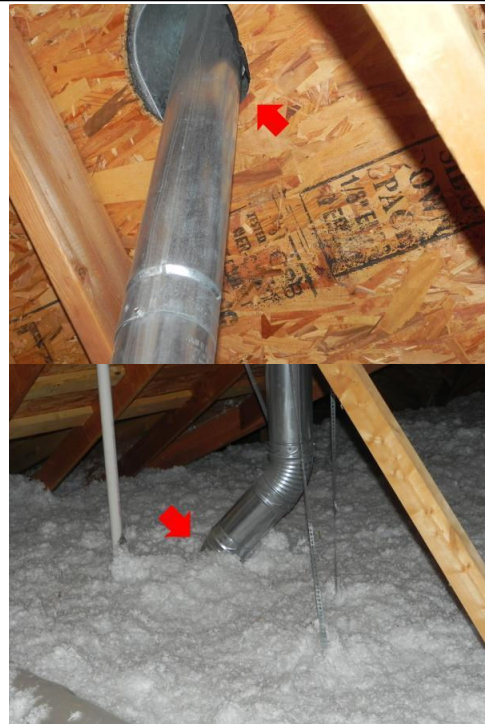
Attic - How Inspected:	Attic was accessed via access steps garage/carport/house interior.
Roof Structure:	Conventional framing. Roof sheathing OSB/plywood/dimensional lumber.
Framing Member Dimensions:	2x6. 2x8.
Attic - Stairs:	Appears serviceable.
Attic Hatch:	Recommend weather strip.
Attic Condition:	Appears serviceable.
Additional Comments:	No soffit vent shutes. Gas Frunace exhaust is touching roof Decking / Gas Fireplace exhaust has Insulation around it.

(Roofing,Attic,Additional Comments) No soffit vent shutes. Gas Frunace exhaust is touching roof Decking / Gas Fireplace exhaust has Insulation around it.

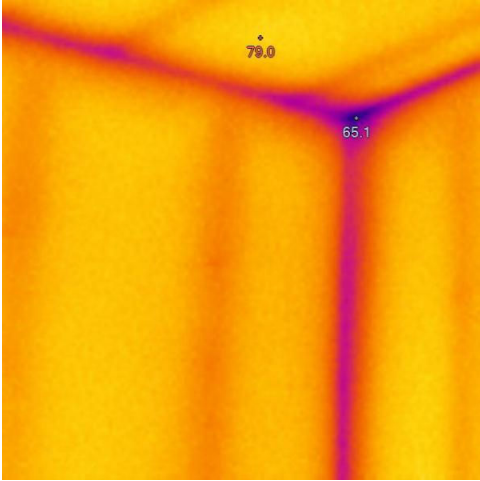
Insulation (Attic)

Attic Insulation Material:	Fiberglass blown.
Attic Insulation Condition:	Appears adequate.
Depth of Insulation:	13 or more inches. Estimated R value is. 38
Additional Comments:	Corners of the house were insulated poorly. Insulation in Drain Pan

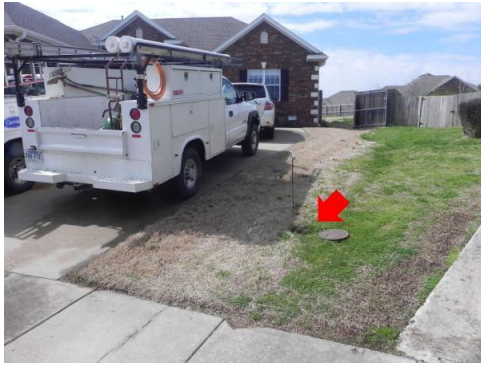
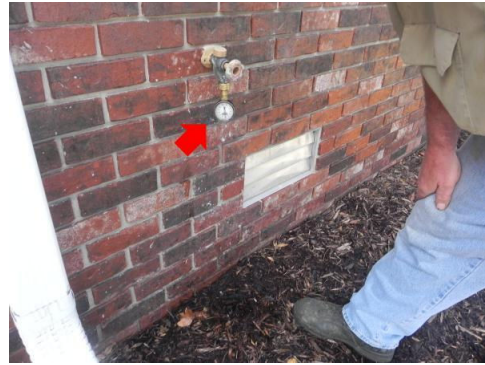
Main Water Line

Main Line Material:	Not determined.
Main Line Service Condition:	Water meter location is: Above 80 PSI.

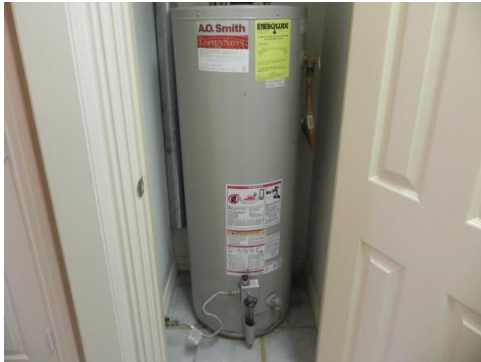
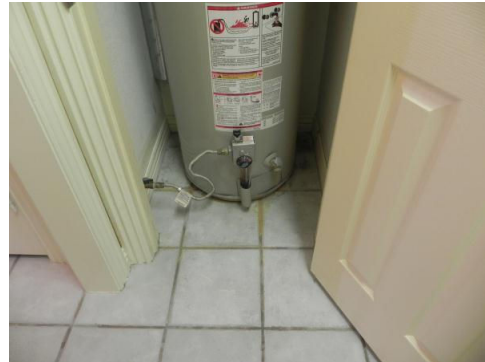
Water Heaters

Water Heater Type (1):	Gas. Manufacturer: AO Smith/ Date of manufacture: March 2001 / . Serial Number: GC01-6359470-548
Water Heater Location:	Utility Room.

Water Heater Condition:	Appears Serviceable
Additional Comments:	Some Discoloration around bottom of Heater at floor. No Drain pan under Water Heater

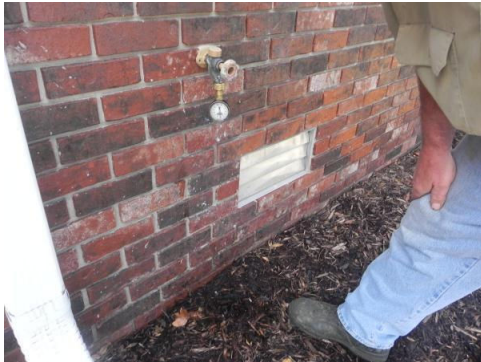
Hose Faucets

Operation:	Faucets are frost proof.
Additional Comments:	Pressure was noted to be high at 90 lbs

(Plumbing,Hose Faucets,Additional Comments) Pressure was noted to be high at 90 lbs

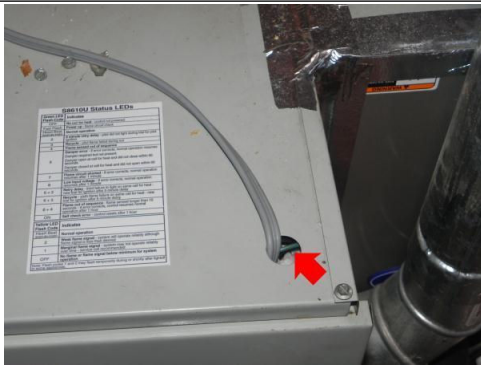
Heating Systems

Heating System Location:	Attic.
Heating System Type:	Forced air.
Fuel Type:	Natural gas.
Capacity of Unit:	BTU: 100,000
Date of Manufacture/Manufacturer:	Manufacturer: Heli / . Date of manufacture: Dec. 2001 / . Serial #:LO11066914
Blower Fan:	Appears serviceable. Noisy. Vibration noted.
Combustion Air:	Appears serviceable.
Venting:	Appears serviceable.
Air Plenum:	Appears serviceable.
Air Filter:	Appears serviceable.
Thermostat:	Appears serviceable.
Ducts, Registers and Grilles:	Appears serviceable.
Venting System:	Appears serviceable.
Additional Comments:	Needs Grommet around House

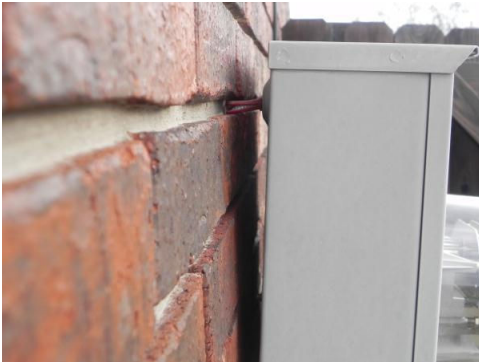
Service Drop and Entrance Type:	Underground. 110/220 Volt.
Service Drop and Entrance Condition:	Appears serviceable.
Additional Comments:	Shut-off pulled slightly away from brick Wall

(Electrical,Service Drop and Entrance,Additional Comments) Shut-off pulled slightly away from brick Wall

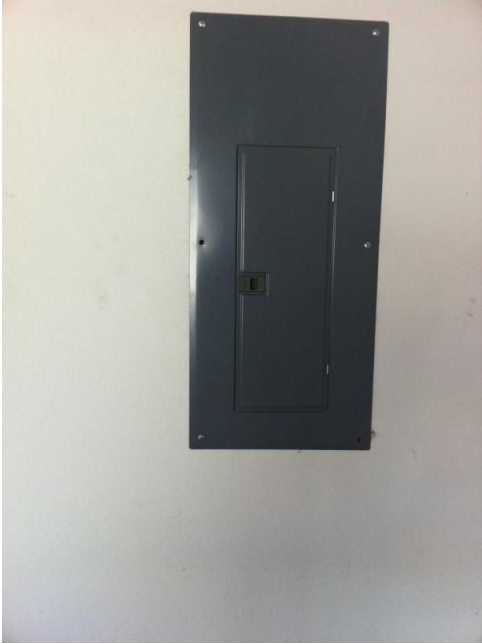
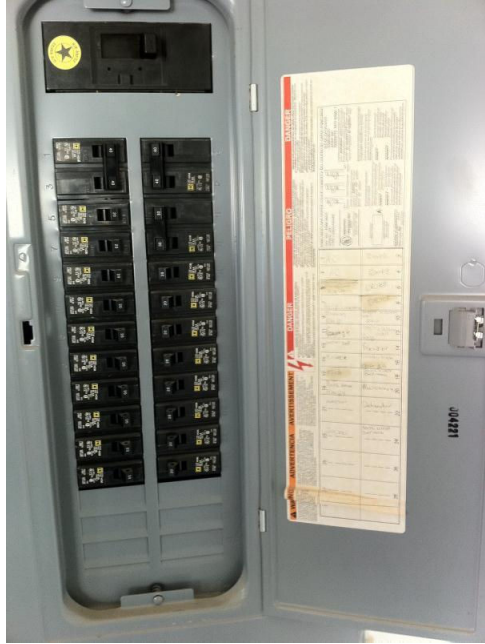
Electrical Panels

Panel Location:	Garage.
Panel Condition:	Appears to be in good condition and labeled
Number of 110 Circuits:	18
Number of 220 Circuits:	3

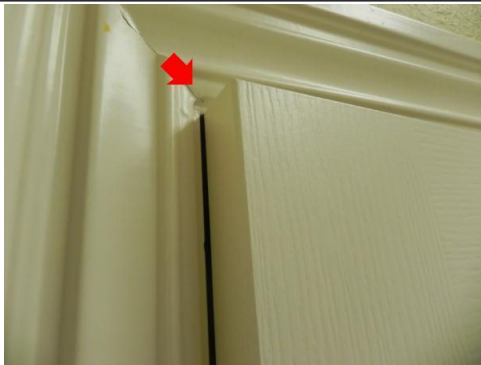
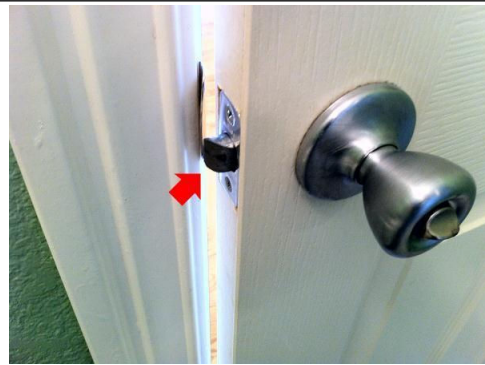
Interior Doors

Interior Door Condition:	Appears serviceable. Some Doors are Hard to close
Additional Comments:	Master Bathroom Door, Latch installed Backward - Water Heater Closet Door sticks at top-left corner

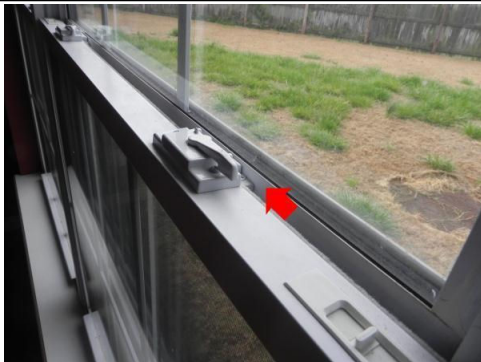
Window Type:	Vinyl.
Window Condition:	Appears serviceable.
Additional Comments:	All Windows are Stiff but do latch and operate, Middle Window in Breakfast Area is difficult to close and Relatch.

(Interiors,Windows,Additional Comments) All Windows are Stiff but do latch and operate, Middle Window in Breakfast Area is difficult to close and Relatch.

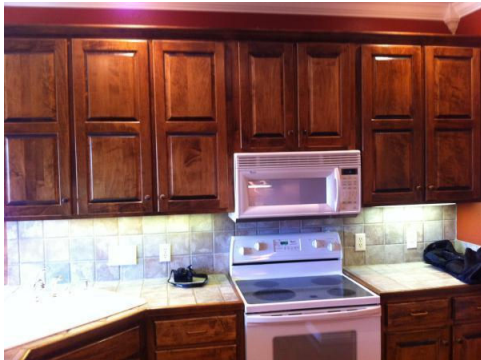
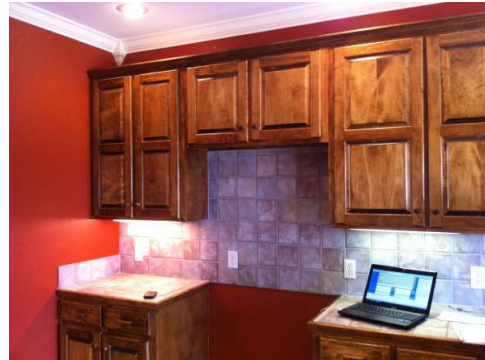
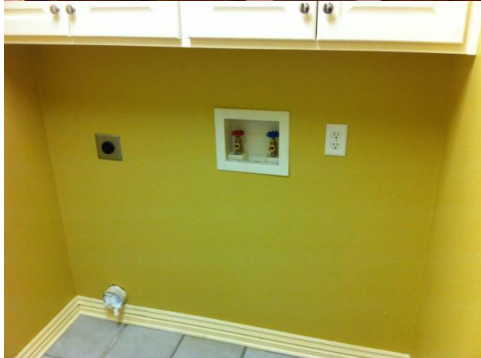
Kitchens

Kitchen Sink Type and Condition:	Porcelain.
Garbage Disposal:	Appears serviceable.
Kitchen Range:	Electric. Free standing. Appears serviceable.
Microwave:	Appears serviceable.
Ventilation:	Internal. Internal. Appears serviceable.
Dish Washer:	Appears serviceable.
Cabinets Condition:	Appears serviceable.
Laundry/Utility Room Location:	Located on main floor.
Laundry/Utility Room Condition:	Plumbing appears serviceable. 220 volts provided and appears serviceable.

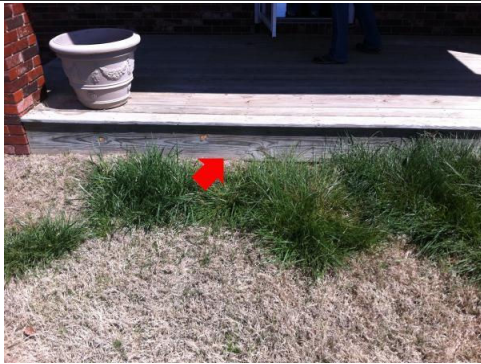
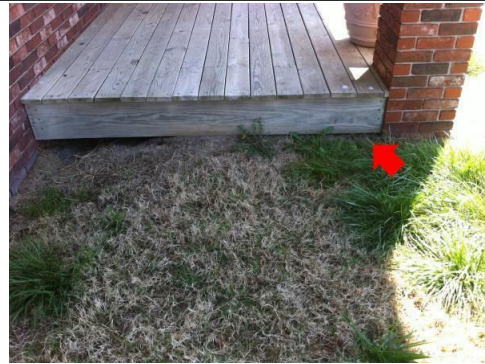
Driveway:	Appears serviceable. Driveway is concrete.
Sidewalks:	Sidewalk is concrete.
Landscaping:	Landscaping is maintained.
Site Grading:	General slope.
Porch/Cover Type and Condition:	Open design. Same as house.
Patio/Decks Type and Condition:	Patio/Deck is wood.
Fences and Gates Type and Condition:	Wood.
Additional Comments:	Wood Patio is touching the Soil. Needs one more step.
